WT-65

This volume is the report of a test program to measure under carefully controlled conditions on the ground the effects of an atomic bomb on aircraft and missile structures. Some measurements of the blast and thermal phenomena peculiar to the USAF problem are included.

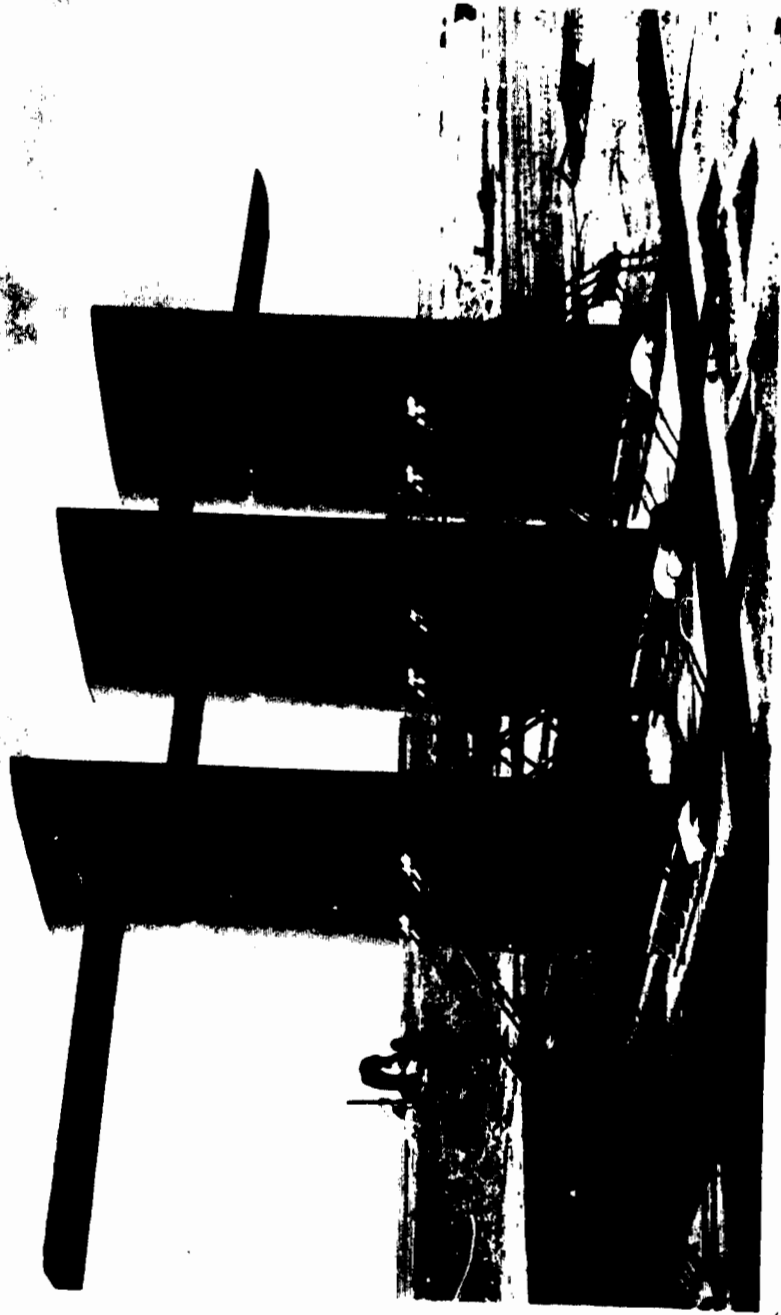
Fig. 1.1 Typical installation of the Rigid and Structural Models before Bomb Burst. The rigid wings are mounted horizontally between the vertical pylons. The structural-wing models are mounted as horizontal cantilevers on the outer pylons. The diagonal rods increase the rigidity of the supporting pylons.

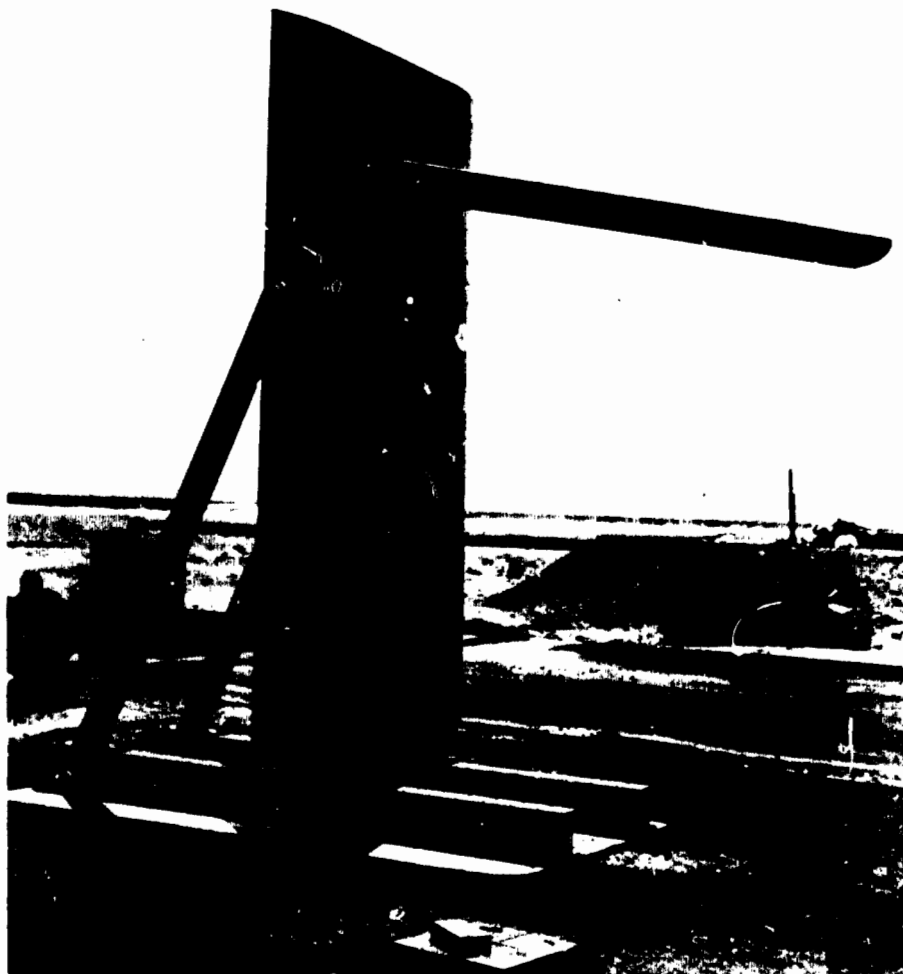
Fig. 1.2 Rigid- and Structural-wing Models on Engebi, Range 4,020 Ft, after Detonation. The structural model 104 at left failed at the root and is actually free to fall except for being wedged in place; note droop.

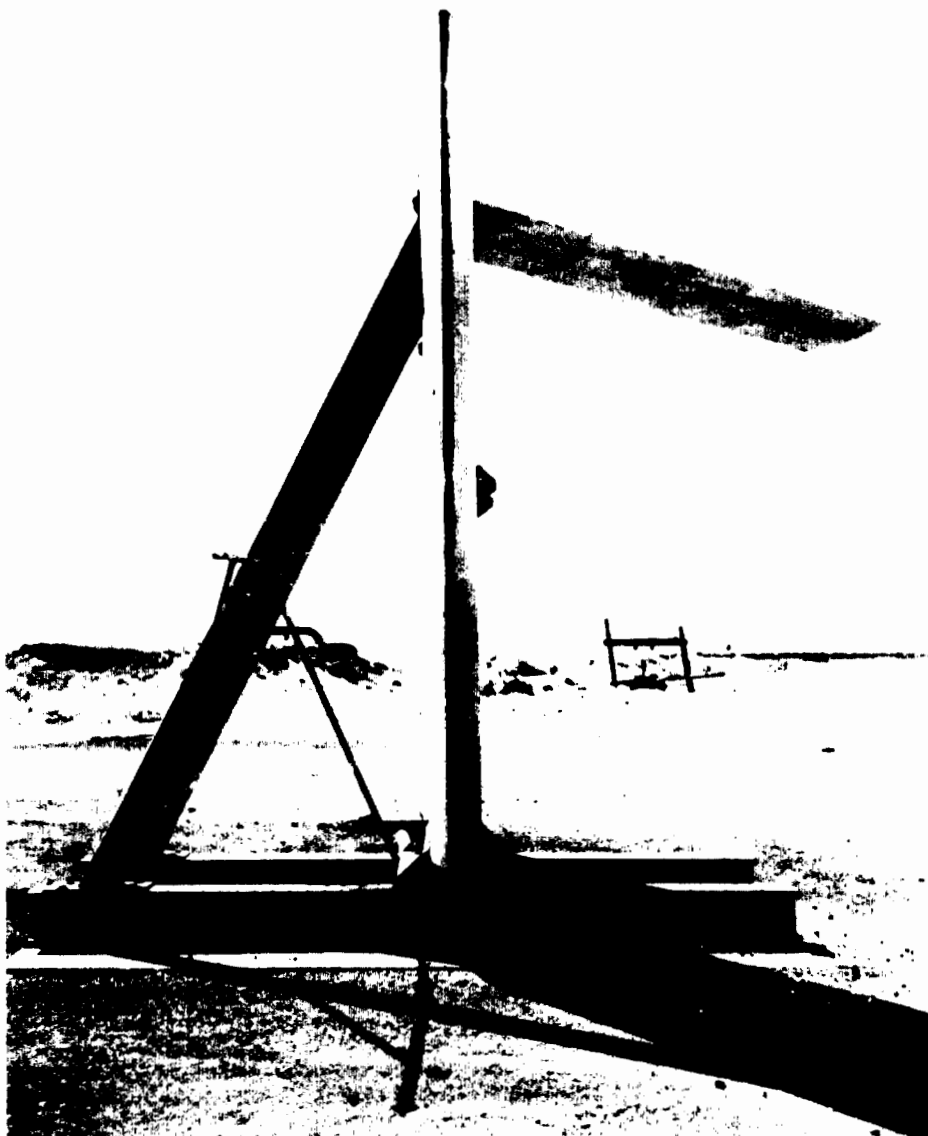
**Fig. 1.3 Typical Installation of Swept-wing Model before Bomb Burst, Engebi, Range 4,020 Ft. The vane-type angle-of-attack measuring device was not mounted on the pylon supporting strut at the time of this photograph.**

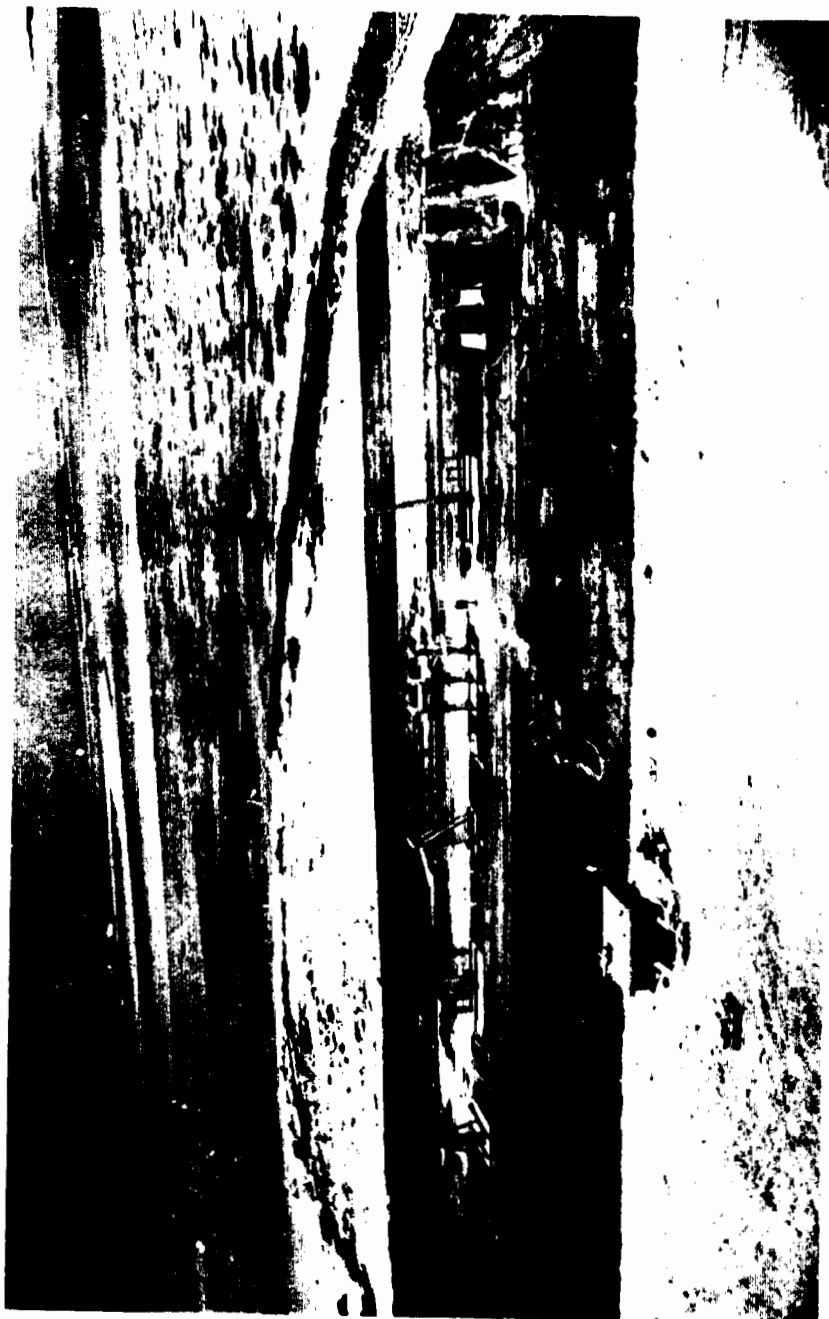
Fig. 1.9 Aerial View of the Test Site on Bokon. The photograph was made from the rear toward the shot tower on Engabl. The shot tower can be distinguished in the upper right corner of the photograph.

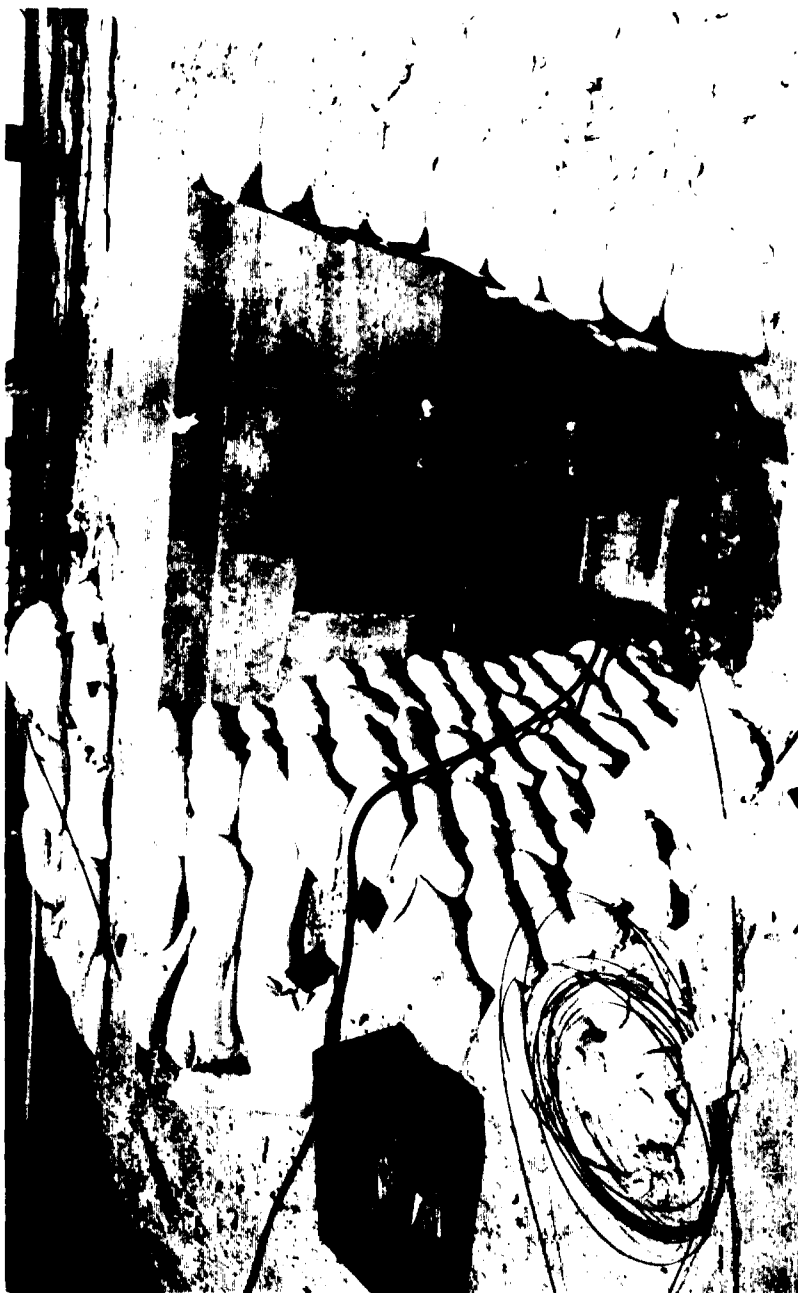
Fig. 1.12 Exterior View of the Instrument Room on Engebi before Bomb Burst, Range 4,020 Ft. The cement dam inside the door was necessary to keep water out of the room at high tide.

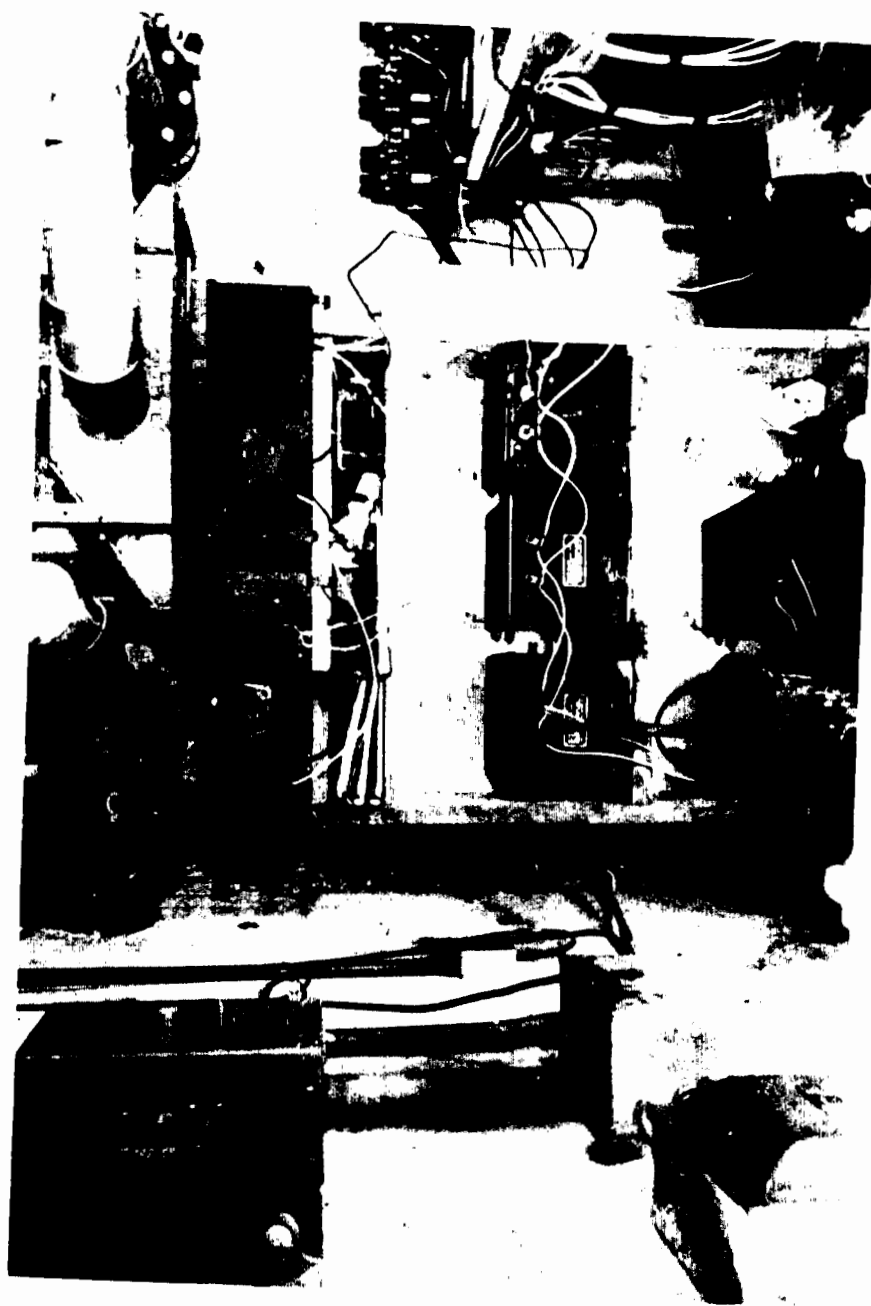
Fig. 1.13 Typical Interior View of a Submerged Instrument Room, Engebli. The rectifiers and batteries for the recorder system are supported on the wooden stand in the center of the picture. The time-signal relays are on the bench at the right. Ducting at the top of picture was part of the forced-air system to cool and remove fumes from the instrument room.

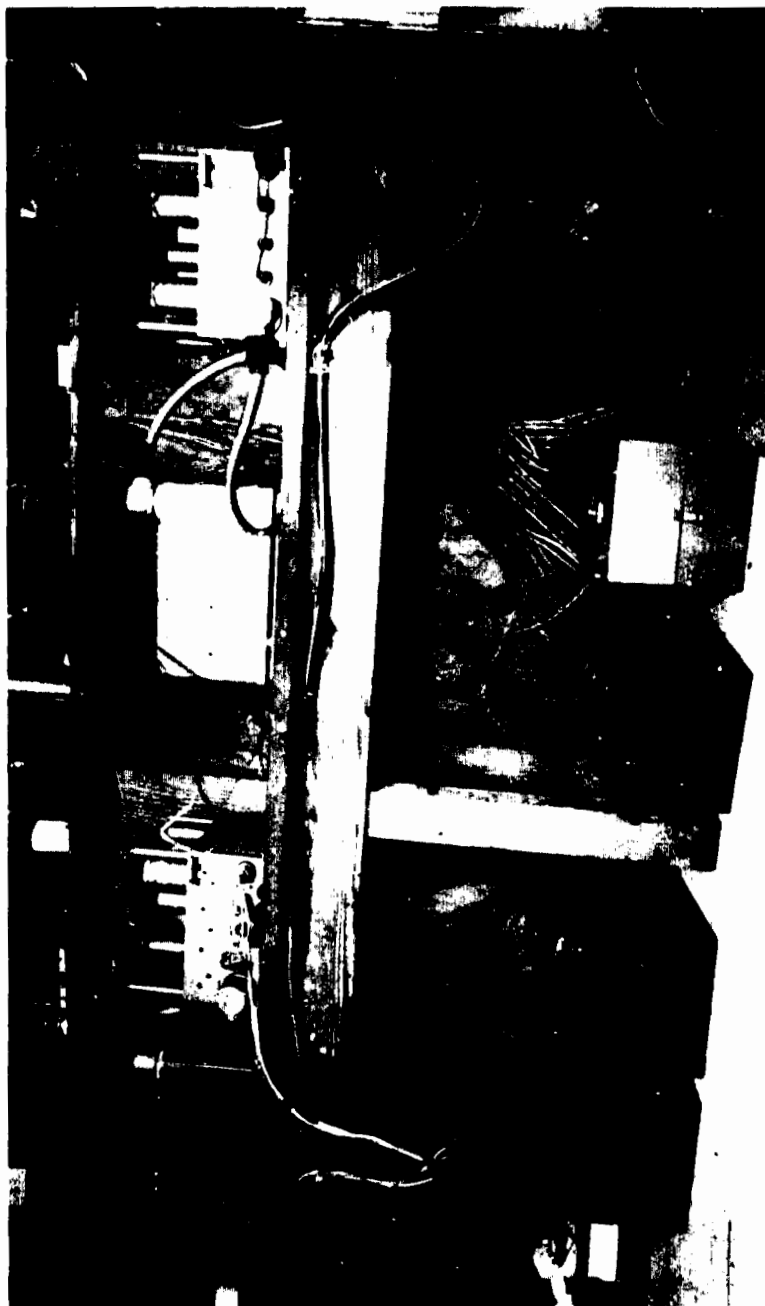
Fig. 1.15 Typical Interior View of a Portion of a Submerged Instrument Room, Bokon. The wires from the structural, rigid, and swept models were conveyed underground in the two conduits and are shown here entering the instrument room.

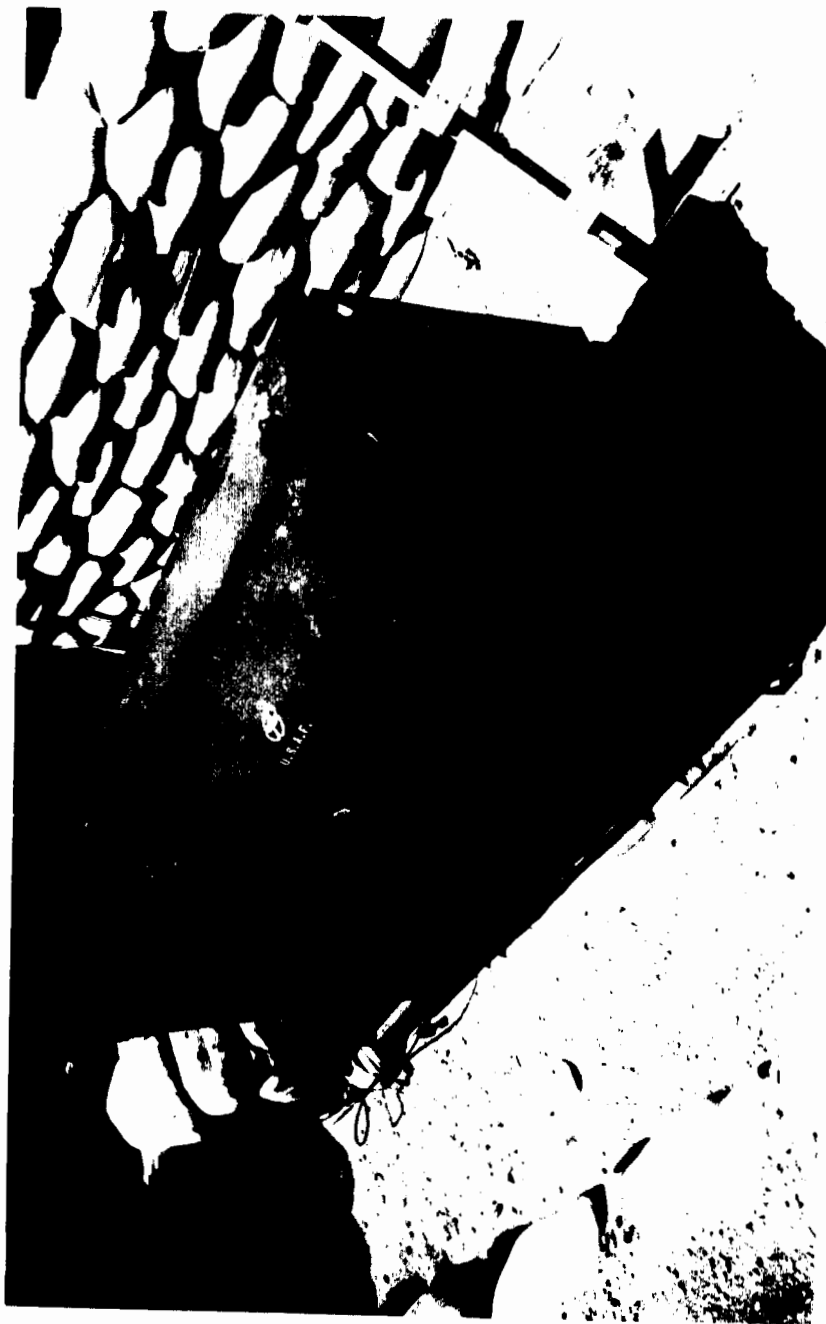
Fig. 1.18 View of 25-kw Generator Installation on Muzin before Bomb Burst. Auxillary 55-gal drum for extension of unattended operating time can be seen to rear of generator.

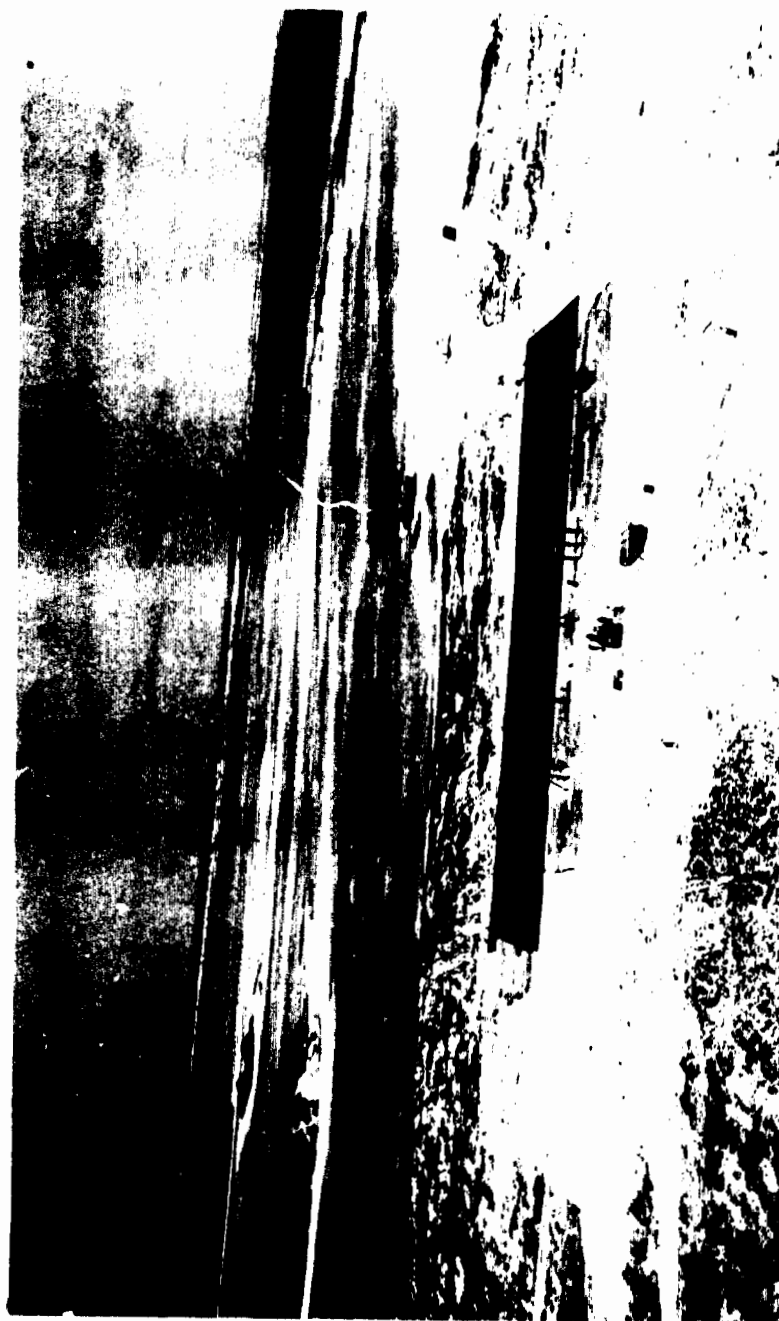
Fig. 1.19 View of 25-kw Generator on Muzin, Range 6,878 Ft., after Detonation. This generator operated successfully through the atomic explosion and was turned off manually on return of personnel after approximately 20 hr of continuous automatic operation.

in good order, although the sandbag revetment had caved in about it (see Fig. 1.19). Debris, such as sheets of metal from the buildings to the rear, littered the asphalt around the test articles. The interior of the instrument house showed no indication of bomb damage. All instruments had functioned and apparently in the proper manner and sequence. The small neon lights on the Potter counters were still lighted, permitting a direct reading of the total counts. The outward appearances of the Muzin test site showed only slight indications of having been subjected to the atomic bomb burst, although the power of the bomb was quite evident in the demolished buildings and debris of the surrounding projects. The radiation intensity determined by the initial survey was 0.3 r/hr.

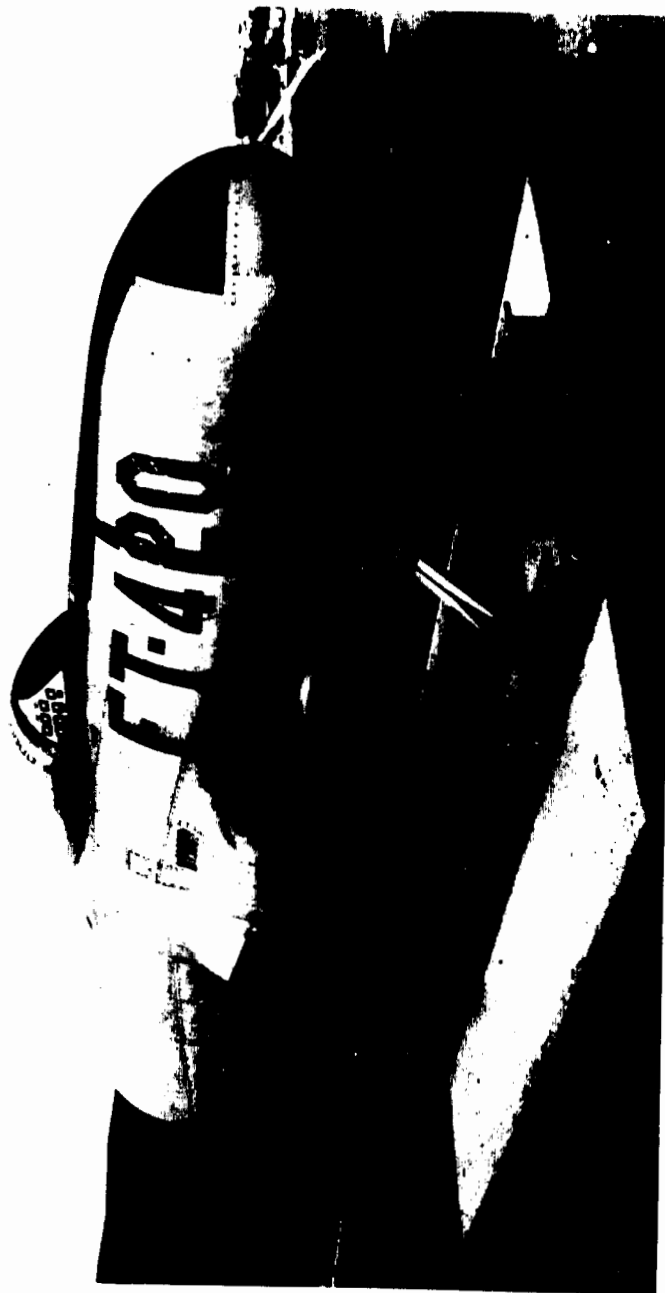
Fig. 2.2 Typical F-80 Fuselage Test Installation, Engeli, Range 4,020 Ft, before Bomb Burst. The Temp-Tapes can be seen on inside surface of the canopy. The dark portion of the fuselage nose is the laminated-glass plastic radar dome.

black in appearance. The test setup is shown in Figs. 2.2, 2.21, and 2.22.

skin between internal supports. Some of these buckles can be observed in the nose section slightly forward of the 0 in the number 420 in Fig. 2.3. The dents in the right air scoop, as shown in the same photograph, were made previous to the explosion, as may be noted in the before picture, Fig. 2.2. Several shallow dished-in areas occurred on the left side of the fuselage nose. The largest area of damage of this nature, including the removable panel over the camera-window cutout, may be seen in the vicinity of the lower part of the F of the large black letters FT-42 of Fig. 2.4. The radar dome on the nose of the fuselage presented a charred appearance. The laminating resin down through the first layer of glass fabric was severely scorched. The canopy withstood the explosion with no outward appearance of damage. However, the rubber sealing strips around the edge of the canopy were burned. The windshield which faced directly into the blast was intact, but crazing and cracking within the laminate were observed.

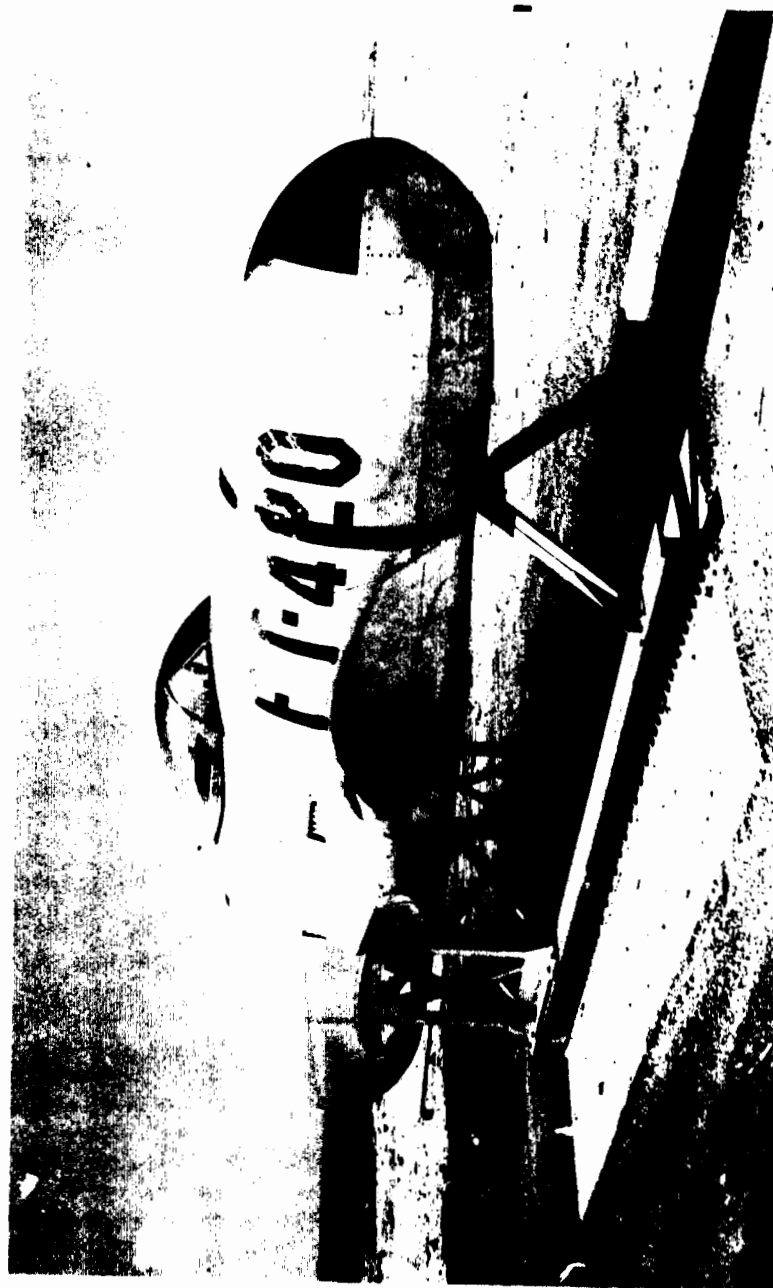
Fig. 2.3 Fuselage on Engebl after the Atomic Bomb Detonation. Note absence of Temp-Tapes from canopy, wrinkle in fuselage skin near the nose, and the burned appearance of the radar dome.

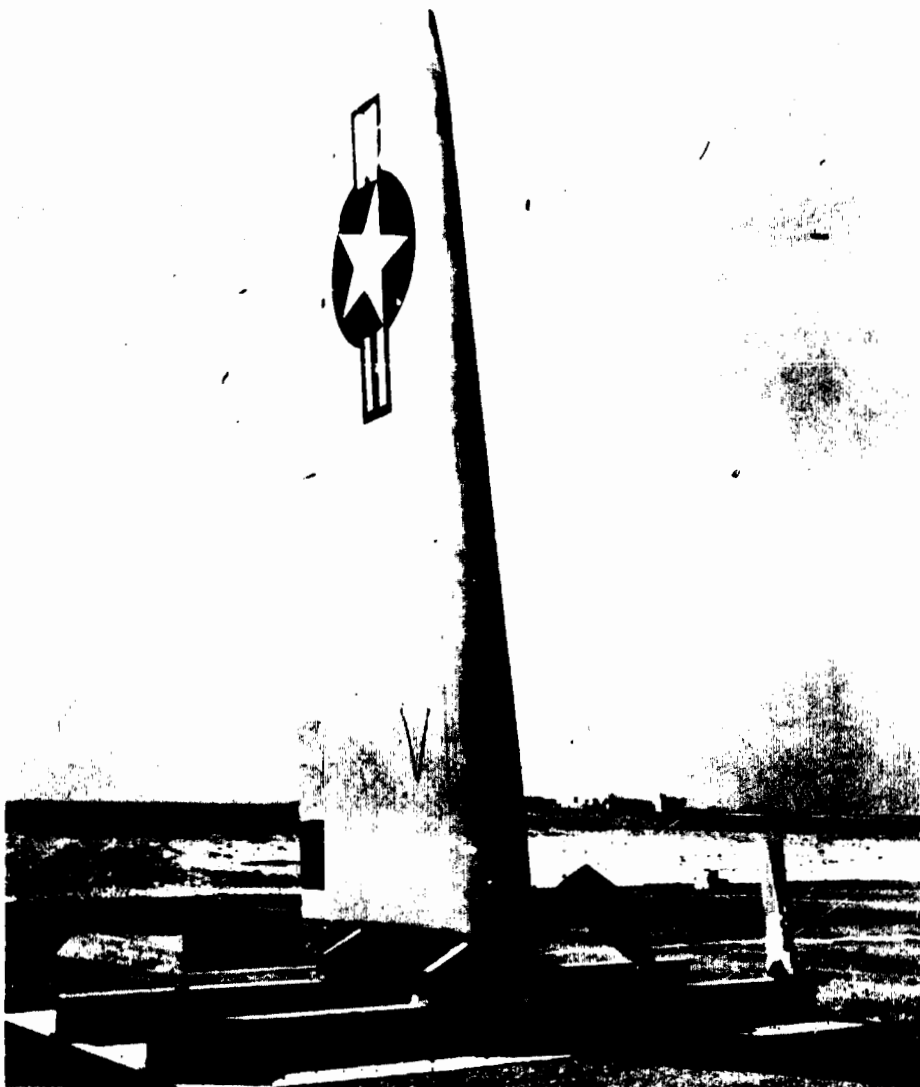
Fig. 2.6 F-47 Wing and Airfoils on Engebi, Range 4,020 Ft, after Detonation. The impression of the internal structure on the skin and the depression of the skin between the ribs is evident. The skin dents on the leading edge near the tip may be seen. The airfoils failed under combined bending and torsion loads.

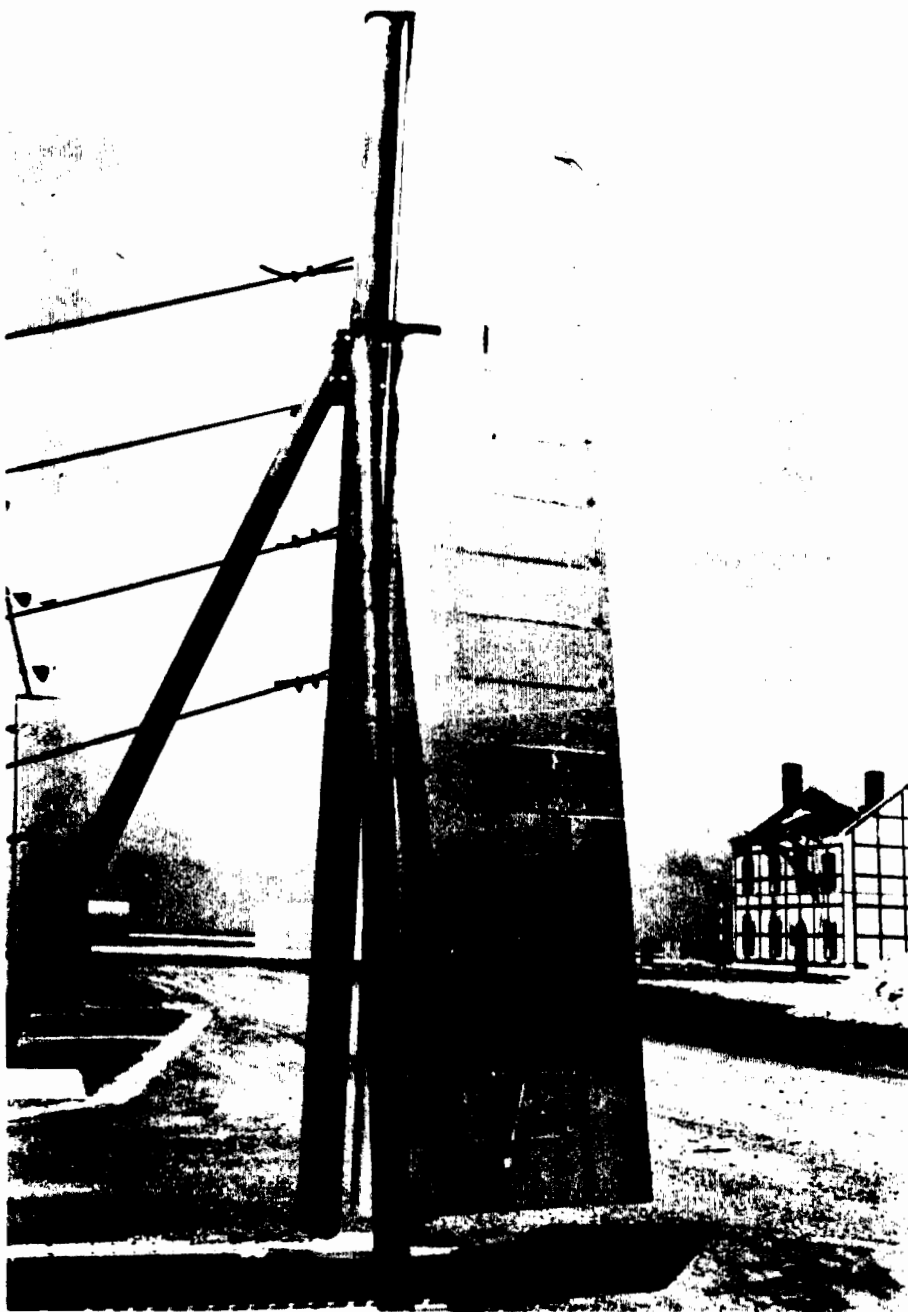
Fig. 2.8 B-17 Elevator on Muzin, Range 6,878 Ft, after Bomb Burst. No damage of any type was sustained.

No effects of the explosion could be observed externally or internally on the B-17 elevators at Muzin, Teiteir, or Bokon (Fig. 2.8). The doped fabric was taut and showed no signs of deterioration.

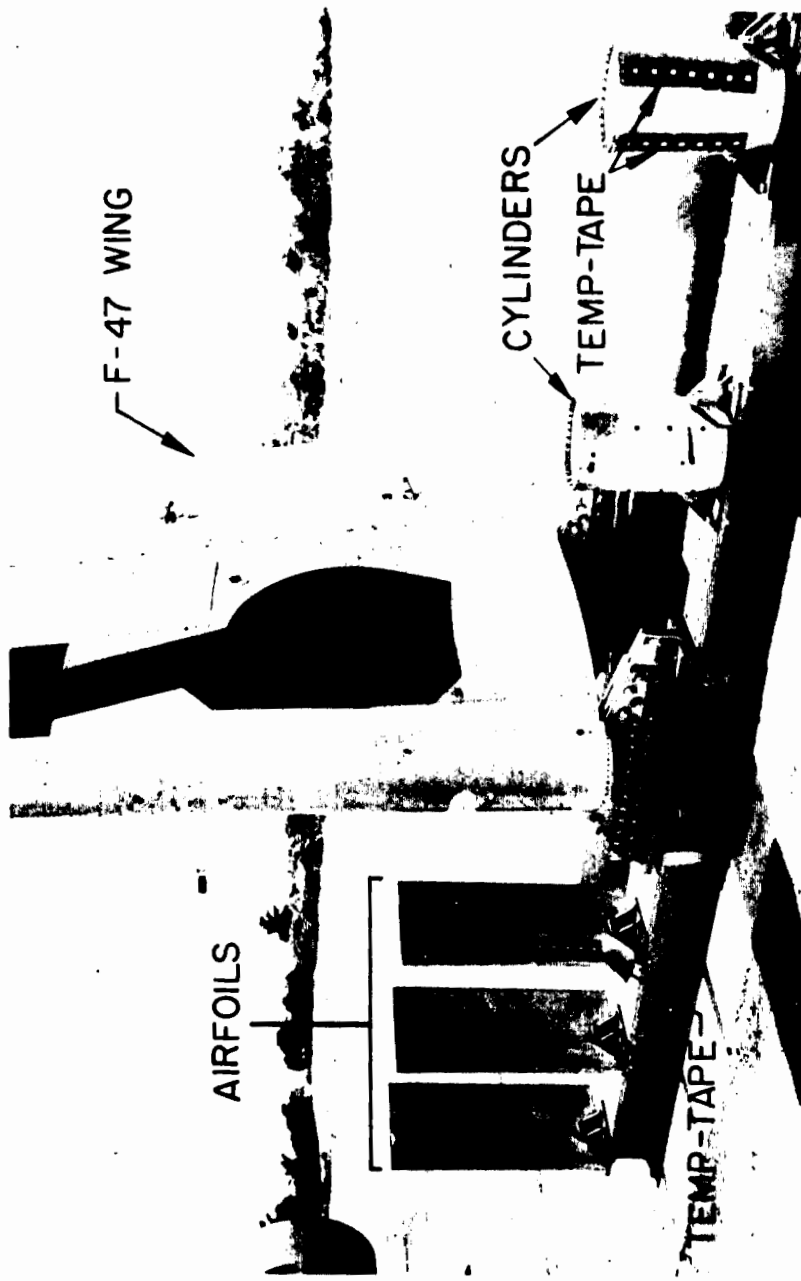
Fig. 2.9 Typical Airfoil and Cylinder Installation before Bomb Burst, Telteir, Range 12,000 Ft. These airfoils are set at 0° angle of incidence.

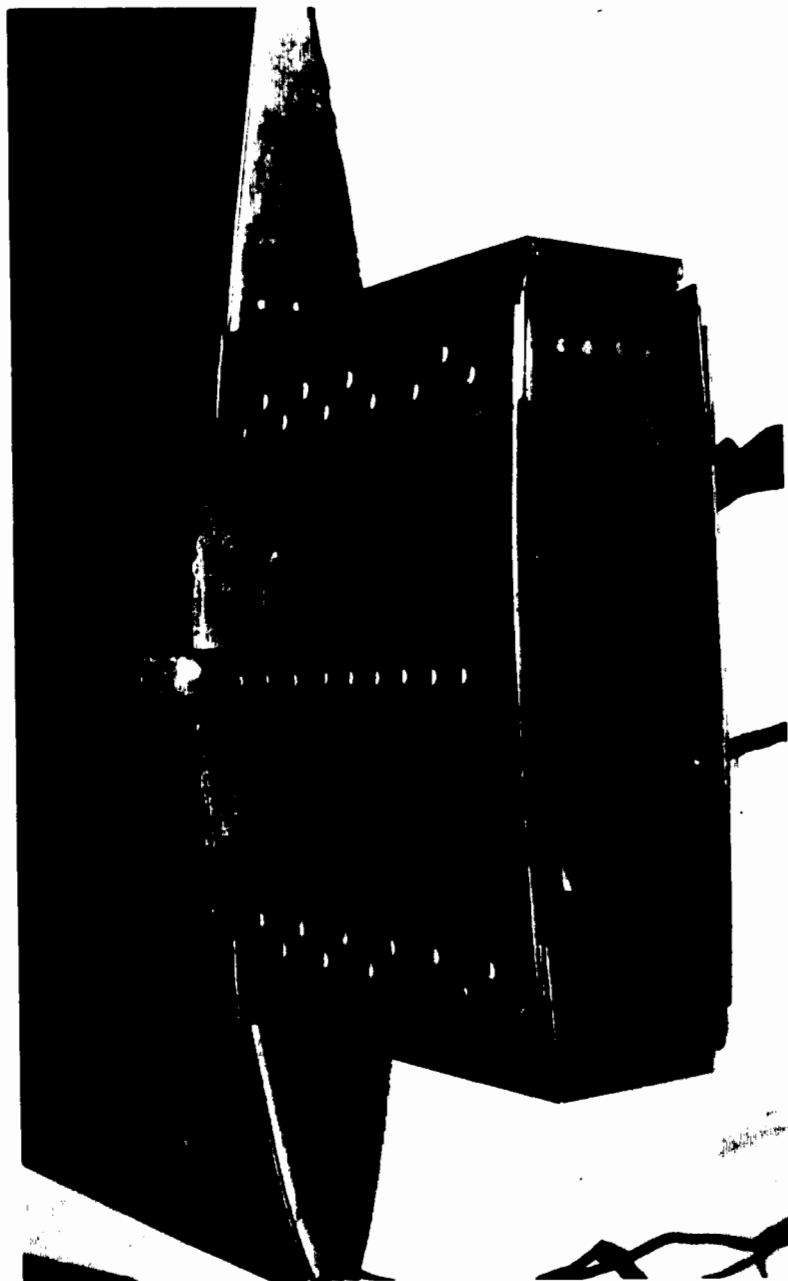
Fig. 2.12 Details of Failed Structural-wing Root Section on Engebi, Range 4,020 Ft, after Detonation. Cracking of both upper and lower spar caps of the root attachment may be seen at A and B. Completely failed intermediate stiffener has been suspended on two wires to show normal position.

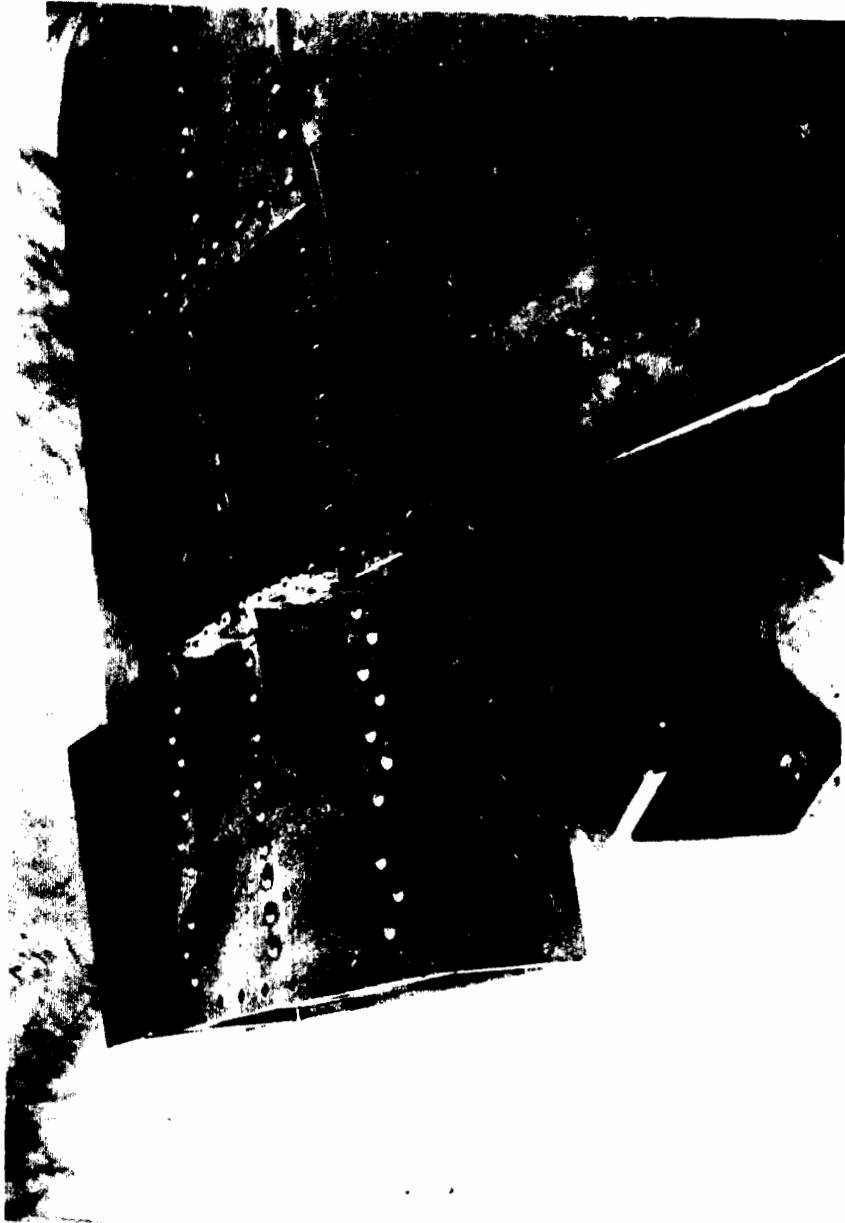
Fig. 2.13 View of the Failed Structural Model 104, Engabi, after Bomb Burst. Sheared rivets at parting face of root fitting E from spar web, bent spar caps at points C, and failed intermediate stiffener D are shown.

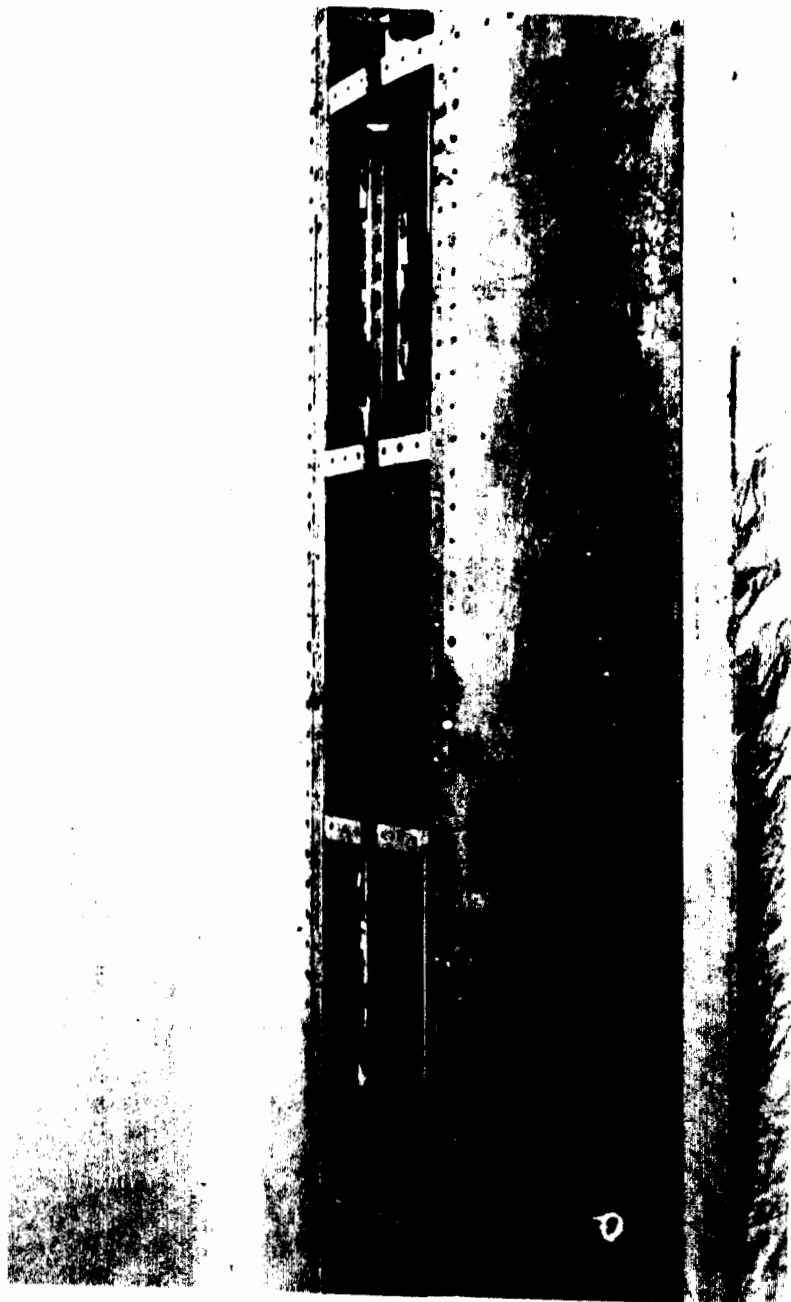
Fig. 2.14 Structural Model (after Bomb Burst) with Top Cover Removed between Spars, Showing Installation of Temp-Tapes. They are on aft face of forward spar and on inside of bottom skin.

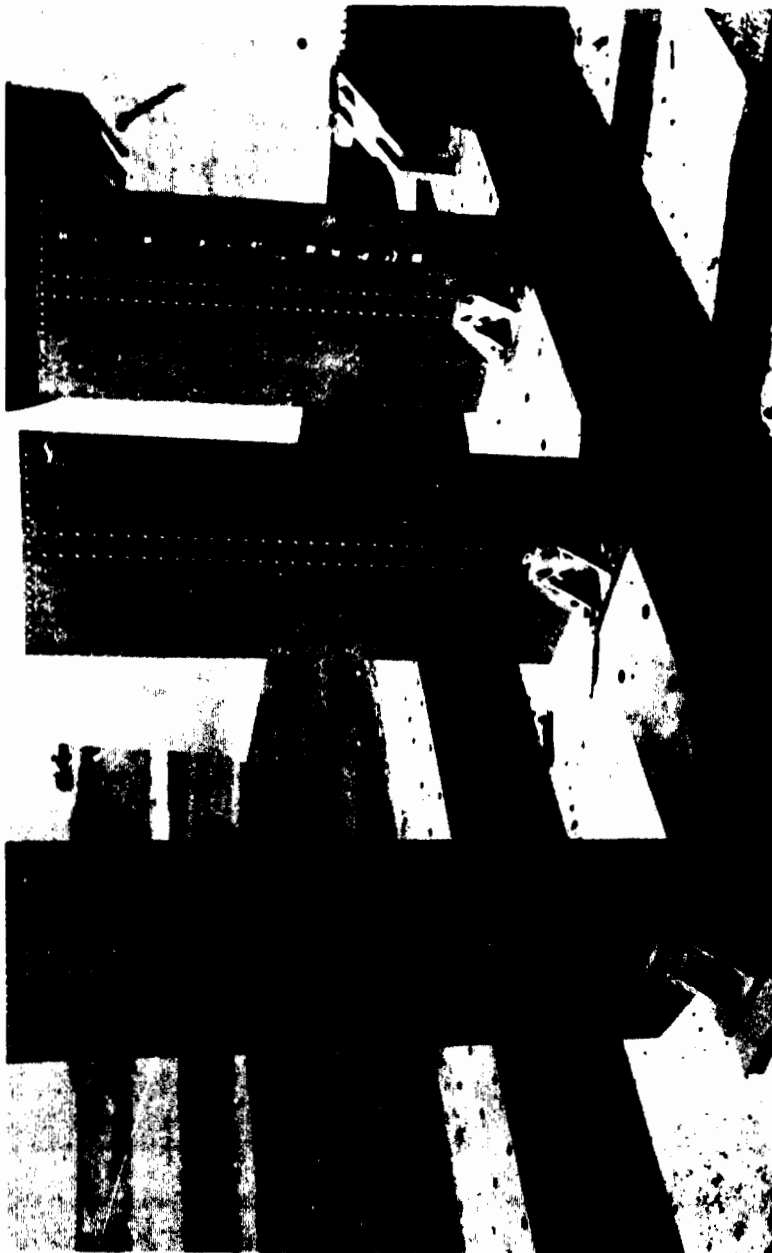
Fig. 2.18 Airfoils Set at 0° Angle of Incidence on Engbel, Range 4,020 Ft, after Bomb Burst. No damage was evident except for slight erosion on leading edge.

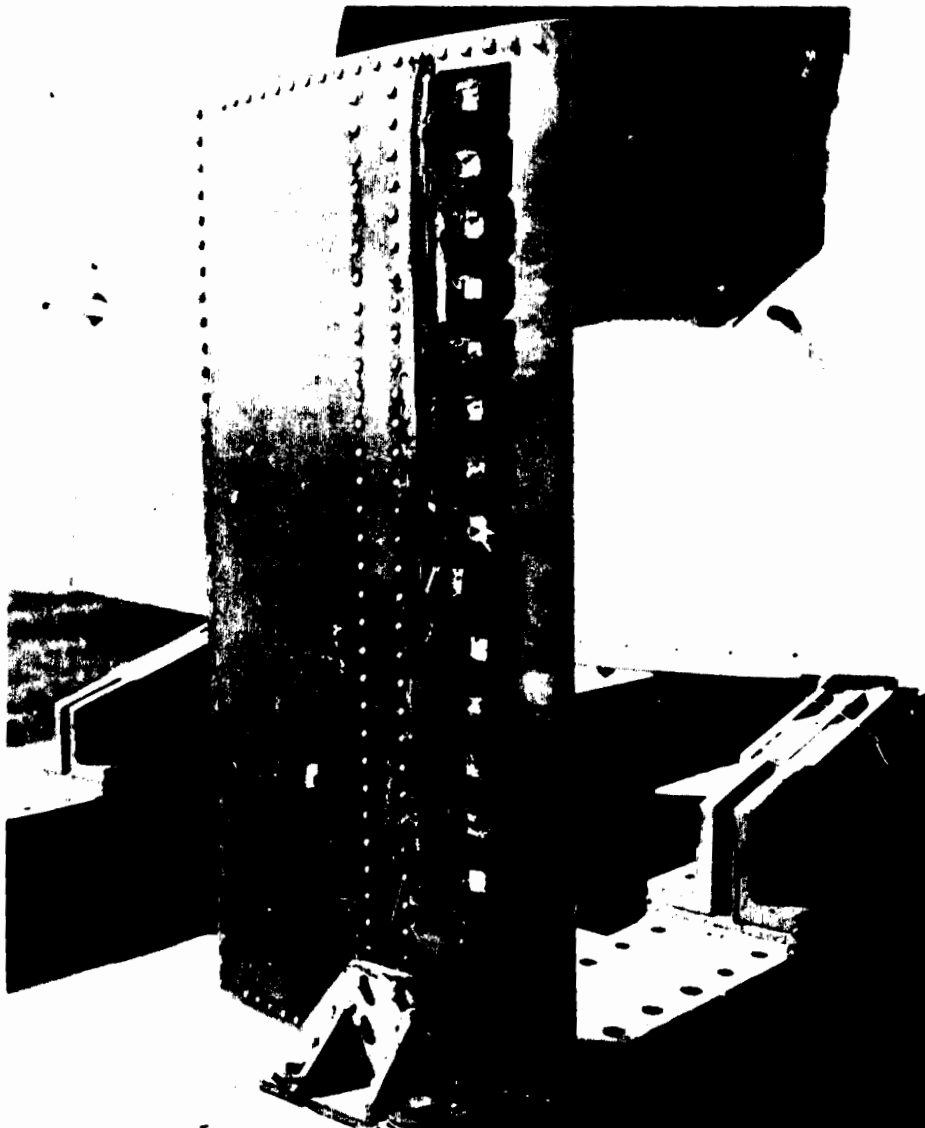
**Fig. 2.19 Detailed View of the Airfoil Shown on Right in Fig. 2.18. Note the severe erosion of the Temp-Tapes.**

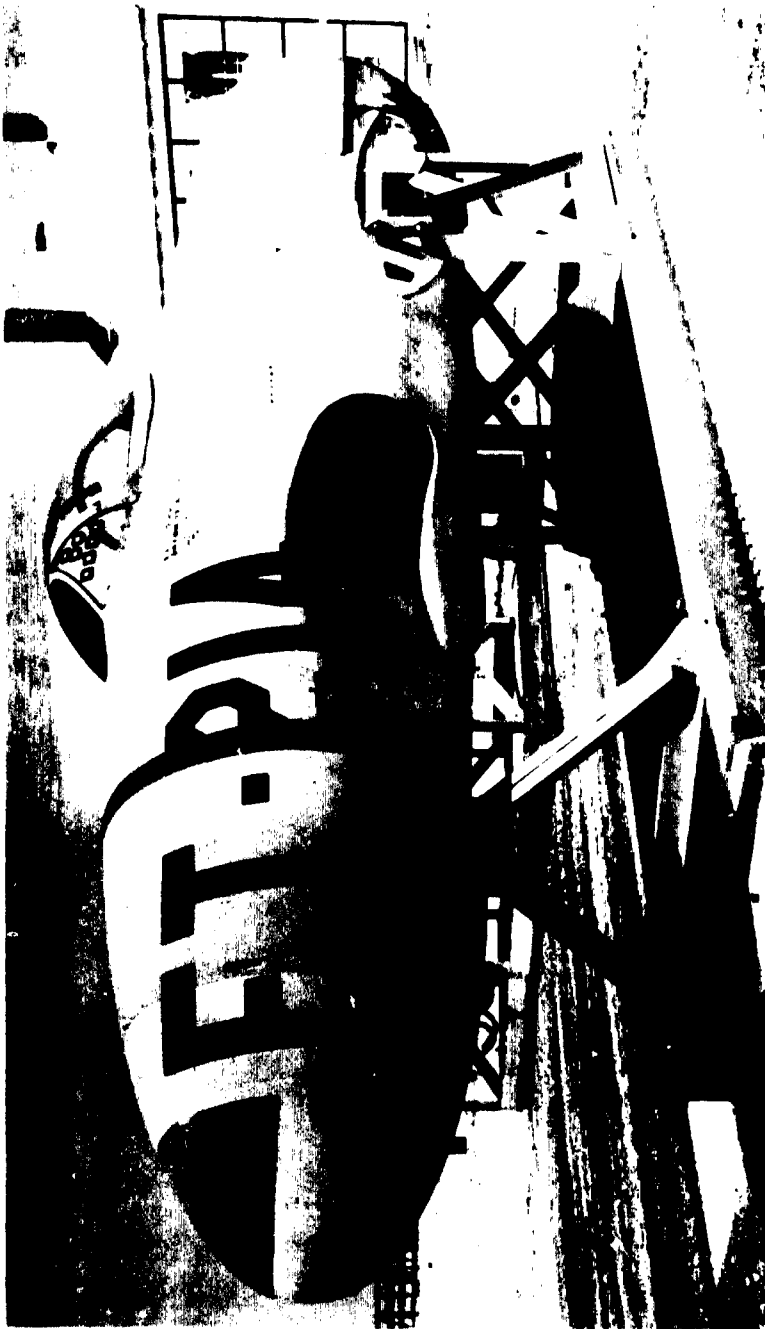
Fig. 2.21 F-80 Fuselage Installation on Muzin, Range 6,878 Ft, before Bomb Burst
